## CERTIFICATE of QUALITY TEST

### Test report - No. 10996.07 / 14

<b>Client</b>	<b>Baumer Hübner GmbH</b> Max-Dohrn-Str. 2 + 4 10589 Berlin	
<b>Equipment under test</b>	<b>Incremental Encoder</b> 1 sample manufacturing date	<b>POG 9 DN 1024 I</b> SN 700001050794 December 2014
<b>Purpose</b>	<b><i>Test of the dynamic-mechanical robustness under defined environmental conditions</i></b>	
<b>Test program</b>	<b><i>Vibration, sinusoidal 10 g</i></b> <b><i>Shock, half-sine 300 g</i></b>	<i>according to IEC 60068-2-6</i> <i>according to IEC 60068-2-27</i>
<b>Test date</b>	5 January to 22 January 2015	
<b>Realization / results</b>	see page 2 to 3	
<b>Total number of pages</b>	7 (incl. 2 appendices)	
<b>Test result</b>	<b>During and after the tests of the Incremental Encoder POG 9 no external damages were determined. The further evaluation will be done by the client.</b>

Test of the dynamic-mechanical robustness of the **Incremental Encoder POG 9** under defined environmental conditions.

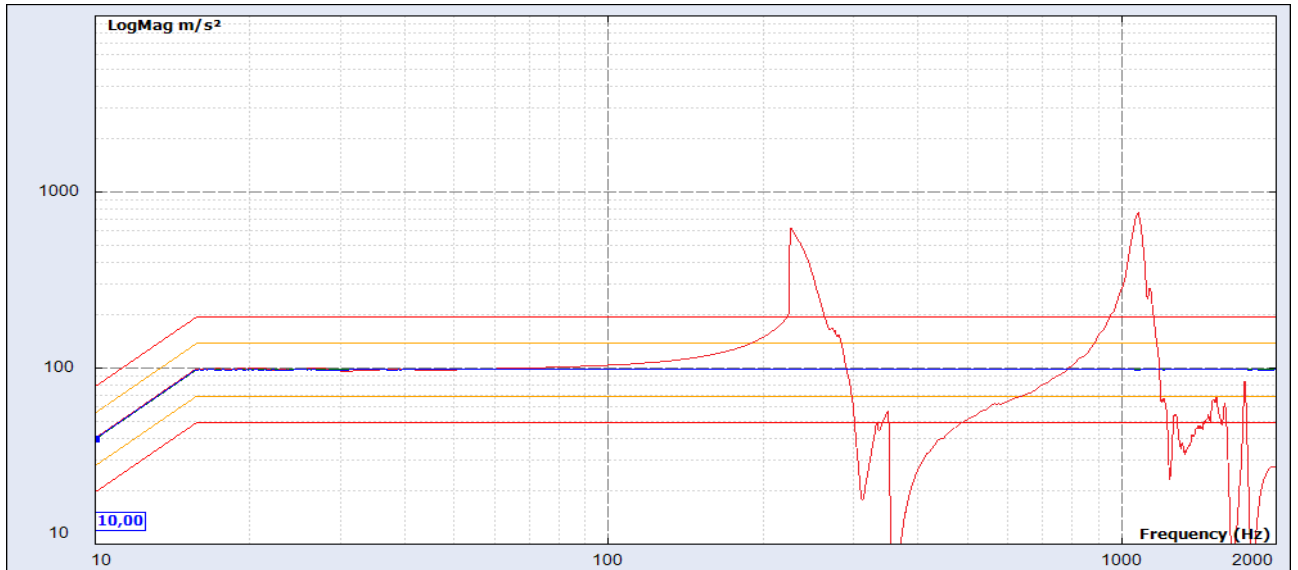
Vibration, sinusoidal, X-axis, - control channel, - acceleration at specimen (channel 3)

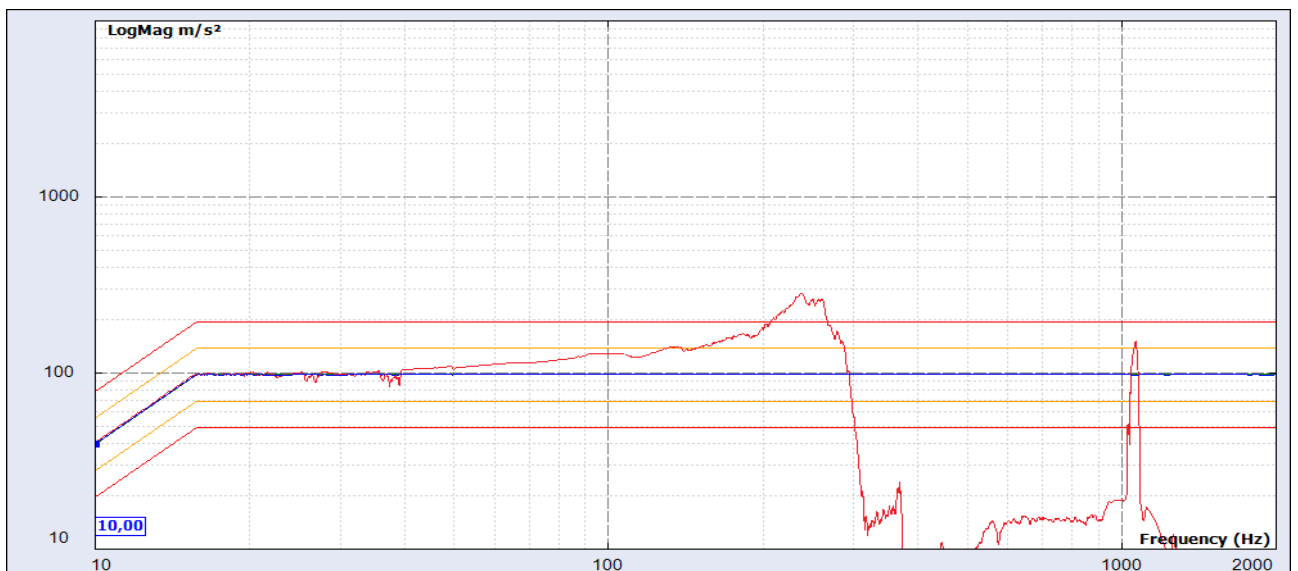
Vibration, sinusoidal, Y-axis, - control channel, - acceleration at specimen (channel 3)

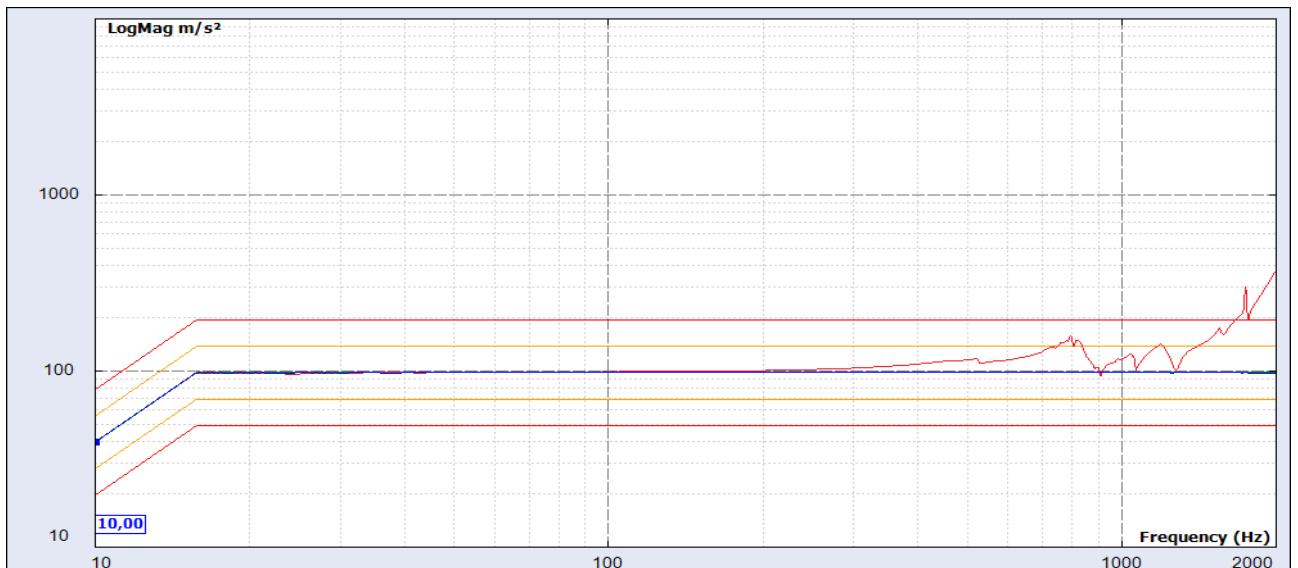
Vibration, sinusoidal, Z-axis, - control channel, - acceleration at specimen (channel 3)

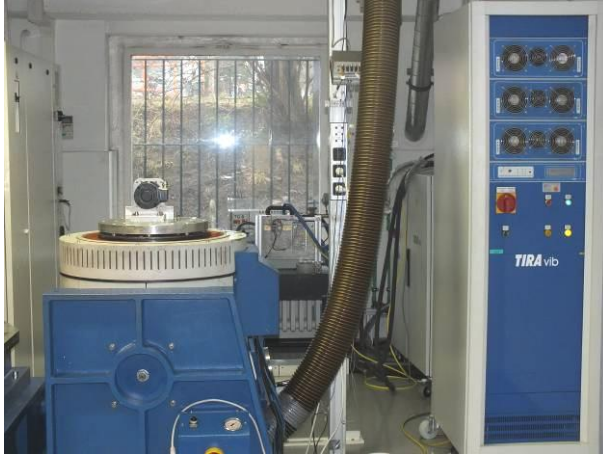
**picture 1**  
Incremental Encoder POG 9  
on the vibration test device  
during vibration test in X-axis

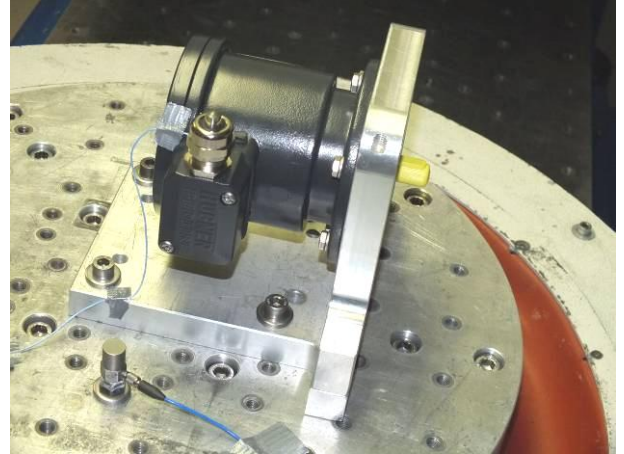
**picture 2**  
Incremental Encoder POG 9  
on the vibration table with acceleration sensors  
during vibration test in X-axis

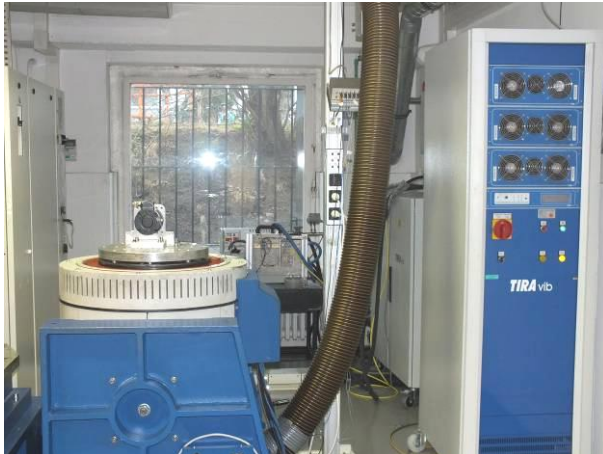
**picture 3**  
Incremental Encoder POG 9  
specimens on the vibration test device  
during vibration test in Y-axis

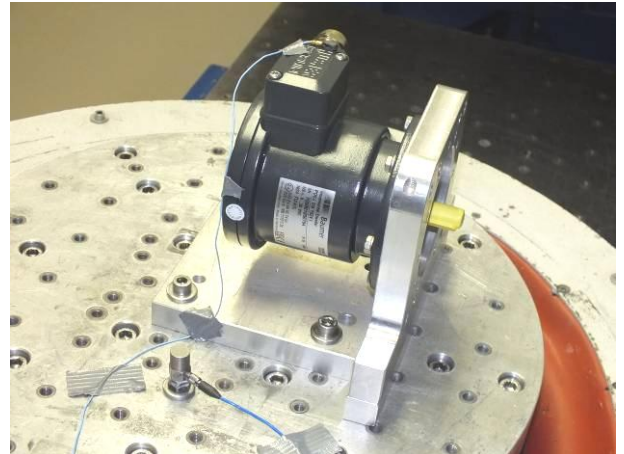
**picture 4**  
Incremental Encoder POG 9  
on the vibration table with acceleration sensors  
during vibration test in Y-axis

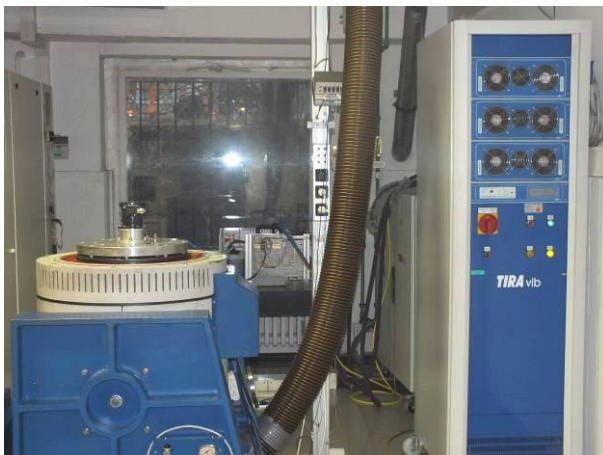
**picture 5**  
Incremental Encoder POG 9  
specimen on the vibration test device  
during vibration test in Z-axis

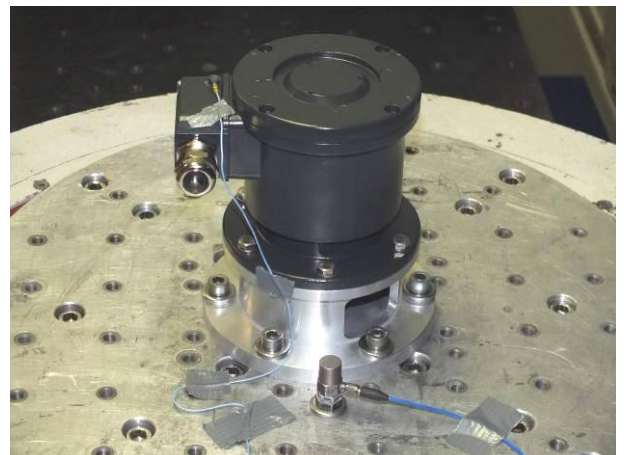
**picture 6**  
Incremental Encoder POG 9  
on the vibration table with acceleration sensors  
during vibration test in Z-axis

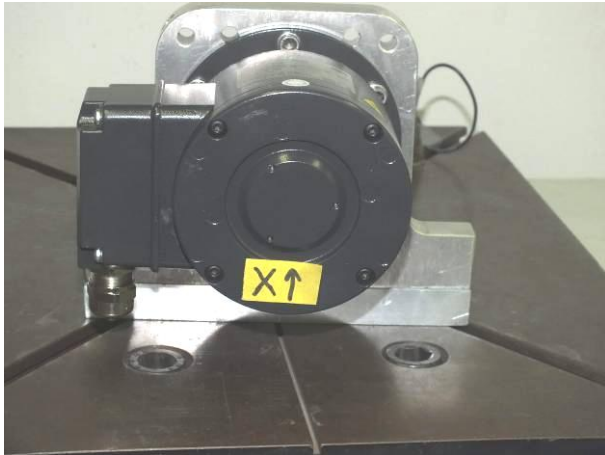
**picture 7**  
**Incremental Encoder POG 9**  
on the shock table with acceleration sensor  
during shock test in X-axis, positive direction

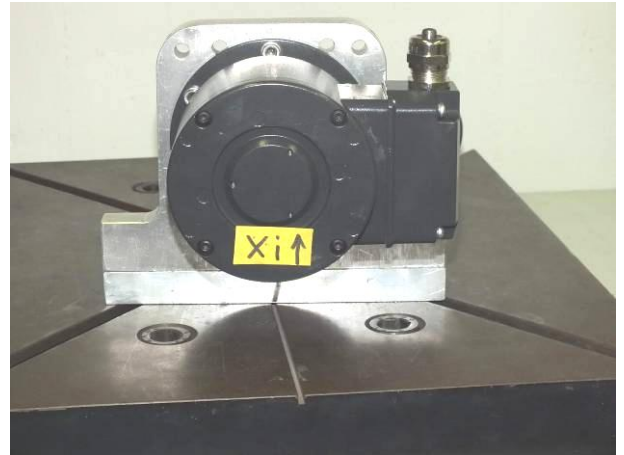
**picture 8**  
**Incremental Encoder POG 9**  
on the shock table with acceleration sensor  
during and shock test in X-axis, negative direction

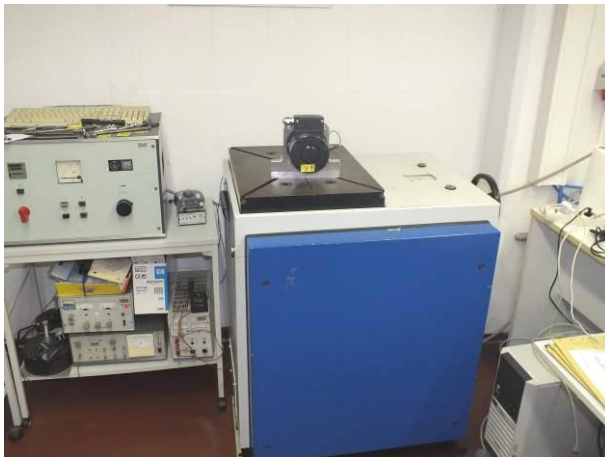
**picture 9**  
**Incremental Encoder POG 9**  
on the shock table with acceleration sensor  
during shock test in Y-axis, positive direction

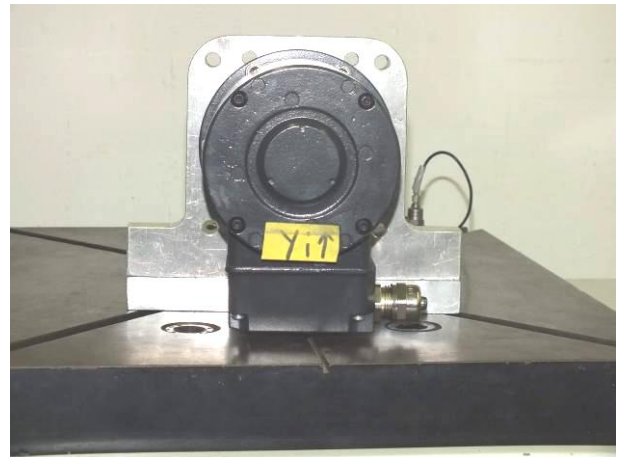
**picture 10**  
**Incremental Encoder POG 9**  
on the shock table with acceleration sensor  
during shock test in Y-axis, negative direction

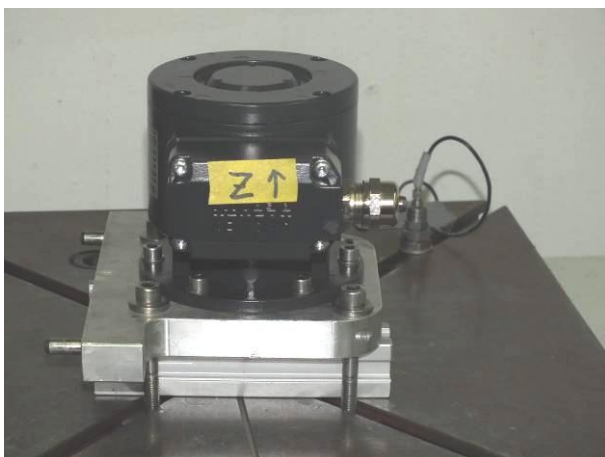
**picture 11**  
**Incremental Encoder POG 9**  
on the shock table with acceleration sensor  
during shock test in Z-axis, positive direction

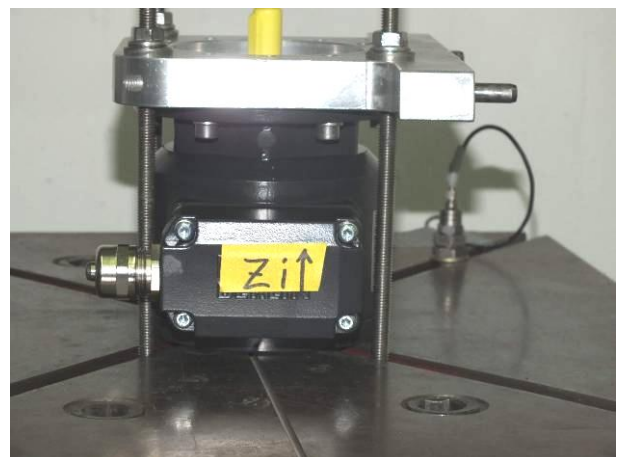
**picture 12**  
**Incremental Encoder POG 9**  
on the shock table with acceleration sensor  
during shock test in Z-axis, negative direction
